Massachusetts Institute of Technology

February 17, 2003

To: XIS Team
From: Mark Bautz
Subject: XIS CCD Edge-glow status

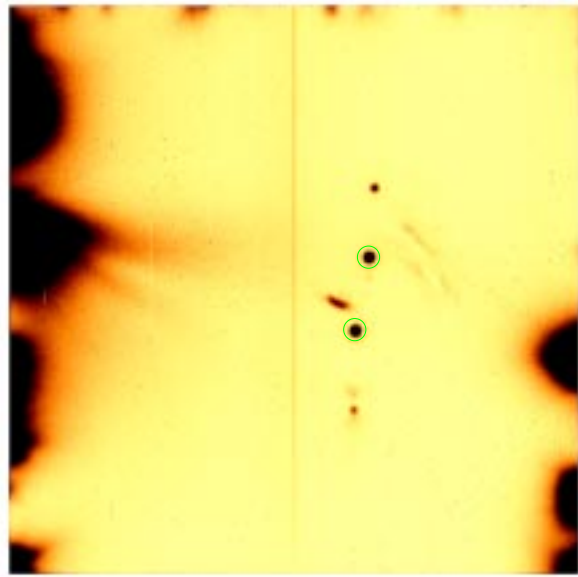
2 January 2003, when edge glow was first discovered, while cooling the detector in the “butthead” chamber. The two spots surrounded by green circles are from alignment lights projected onto the CCD. The detector temperature is unknown, but is significantly warmer than -90C. Some dark current spikes are evident.

Figure 1: Examples of edge glow in XIS detector L1W4C6 = w1.4c6. All images are shown at the same color scale, with black indicating high signal ($\sim 500e^-$) and yellow indicating low signal. Each is a single 8-second exposure, and cosmic ray tracks are evident. Quadrant A is to the left and row 1 is at the bottom.

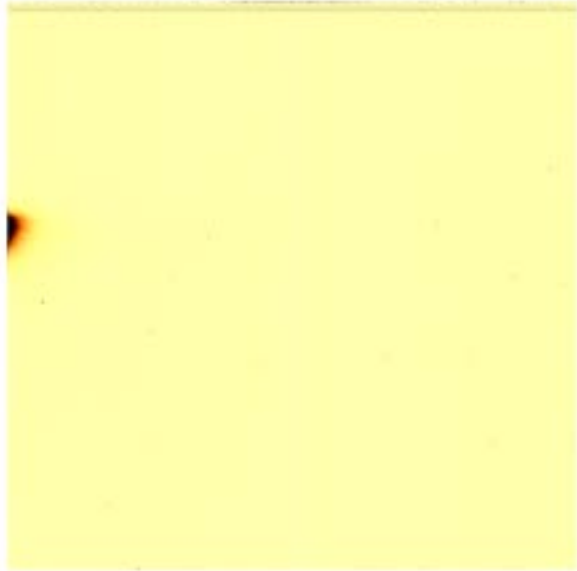
7 January 2003 in the IFM chamber. The glow has changed considerably. The dark features at the top are intentionally injected via the charge injection register.

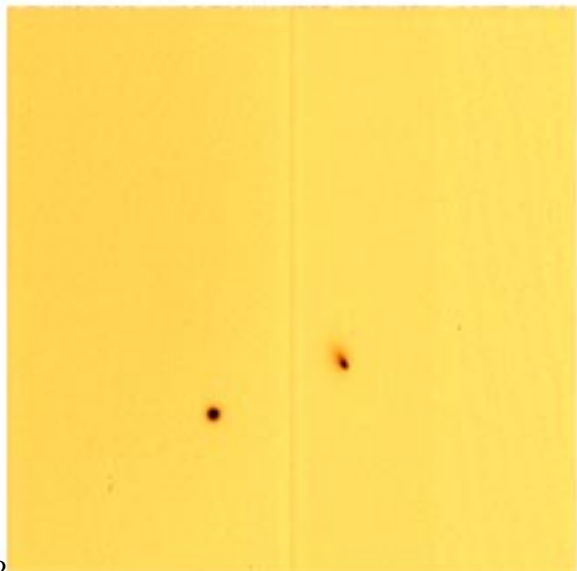
10 February 2003 in the butthead chamber. The glow has disappeared.

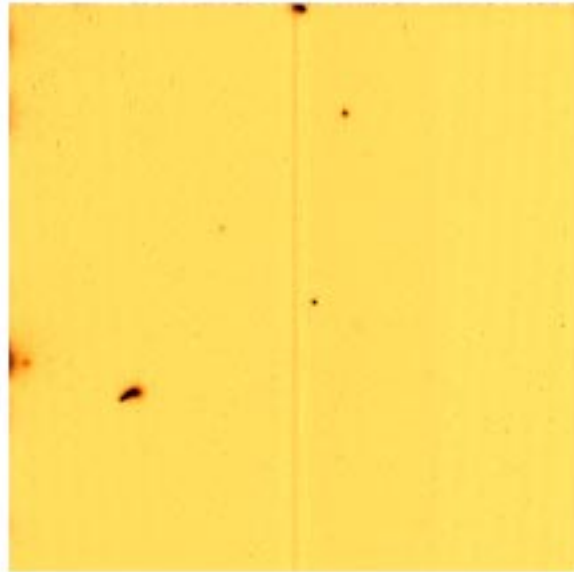
28 January 2003, just after edge glow was detected in w1.4c7, following a roughing pump failure in the “butthead” chamber. The glow region is much smaller than seen on w1.4c6.

Figure 2: Examples of edge glow in XIS detector L1W4C7 = w1.4c7. All images are shown at the same color scale, with black indicating high signal ($\sim 500e^-$) and yellow indicating low signal. Each is a single 8-second exposure, and cosmic ray tracks are evident. Quadrant A is to the left and row 1 is at the bottom.

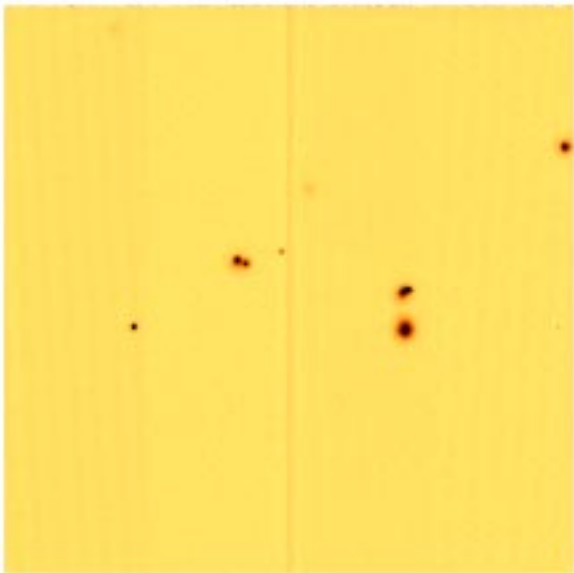
14 February 2003 in the butthead chamber. The glow has vanished.
