ACIS Memo # 182
Massachusetts Institute of Technology
Center for Space Research
Cambridge, MA 02139
Room NE80-6053/37-518A
cgrant@space.mit.edu

To: ACIS Team
From: Catherine Grant
Subject: Quantum efficiency of ground irradiated device as a function of row and energy
Date: 07 March 2000

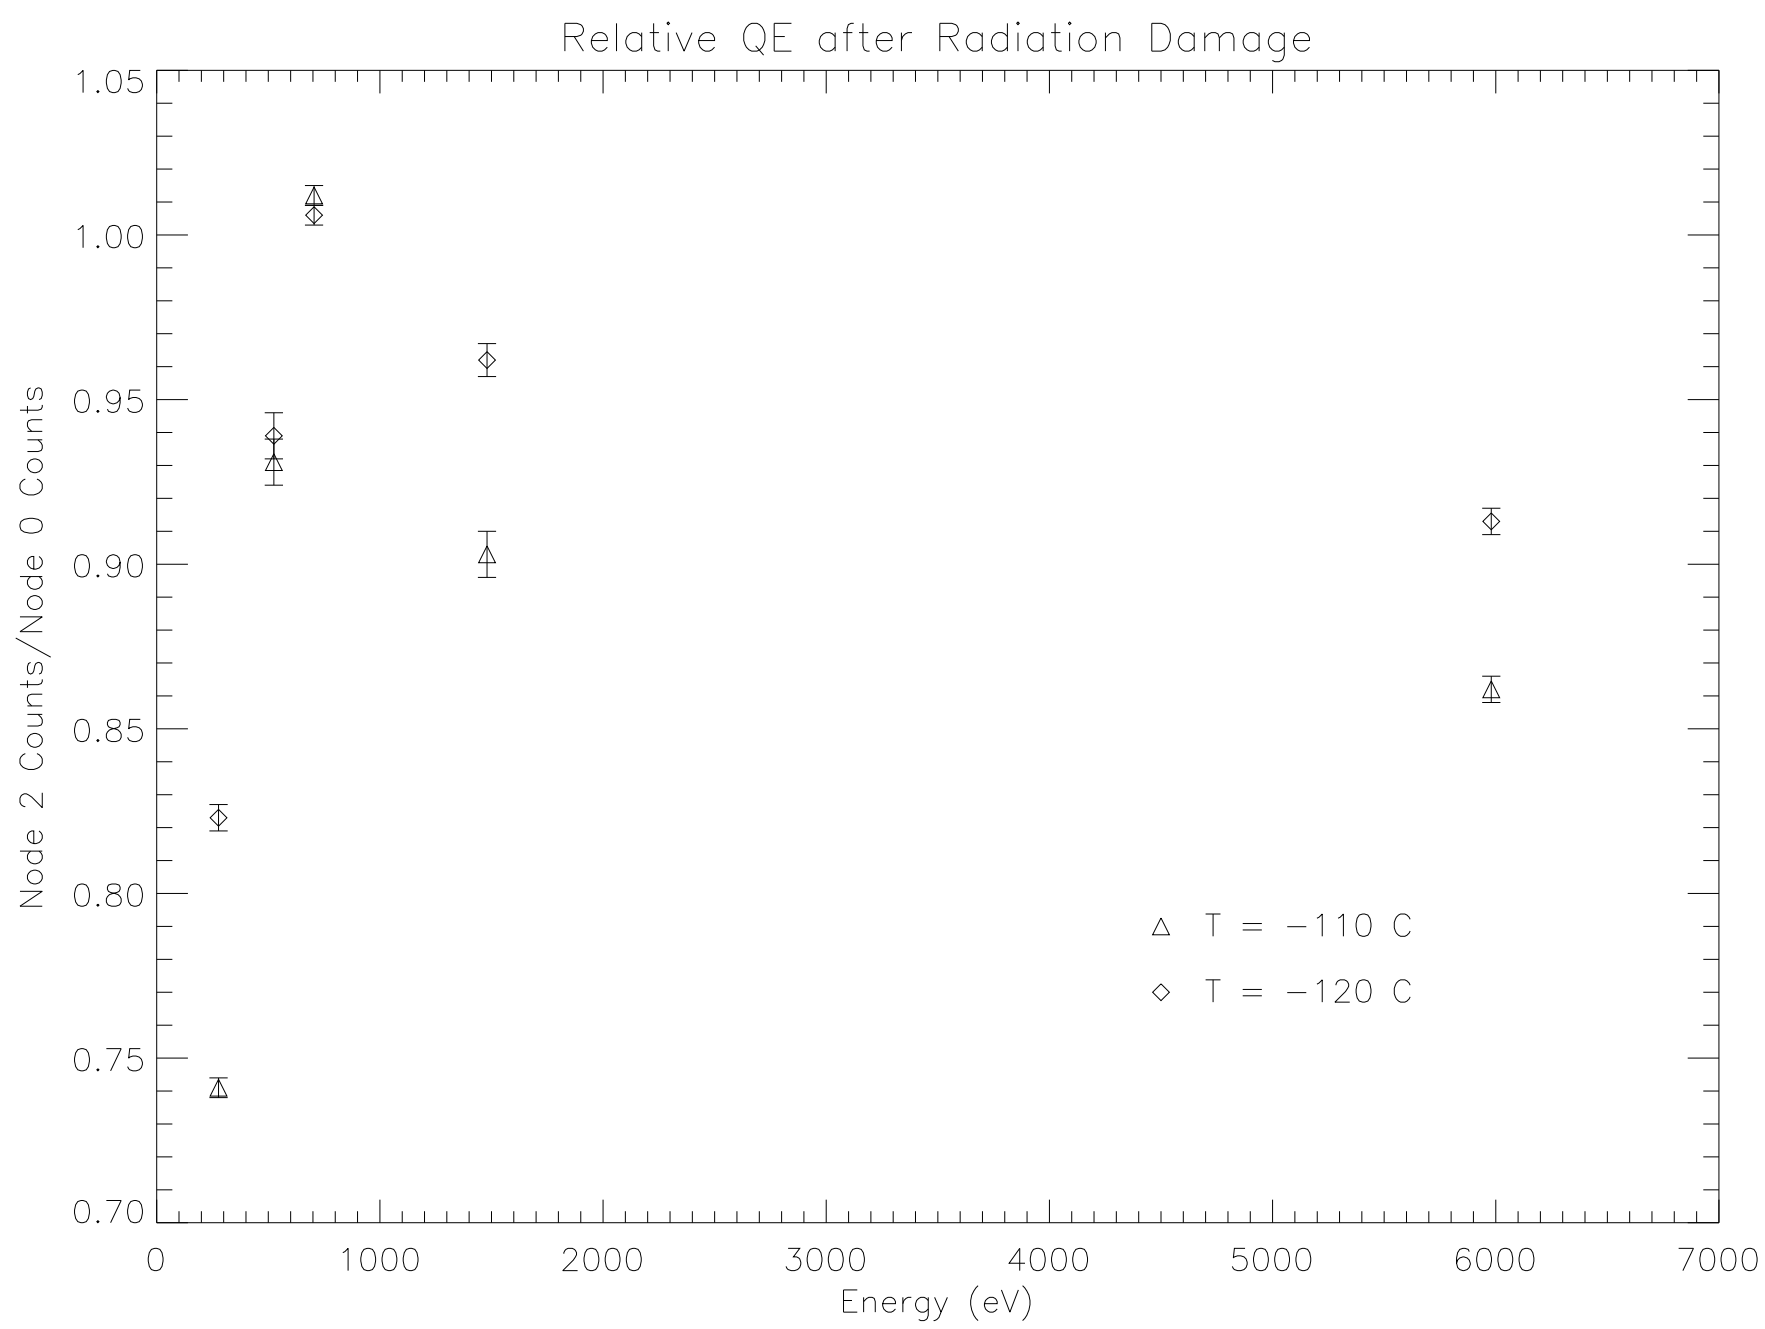
Figure 1 shows the relative QE of Node 2 to Node 0 as a function of energy over all rows. At lower energies, the QE at the C-K line is substantially degraded by the CTI, while the O-K, Fe-L and Al-K lines are relatively unaffected. This is because for C-K at high row numbers the event threshold of 38 is of order the pulseheight of the spectral line. At higher energies the loss of QE is from grade morphing of valid X-ray events into 'bad' grades, primarily G7.

Figure 1: The relative QE of the radiation damaged node to the undamaged node at a temperature of -110 and -120 C.

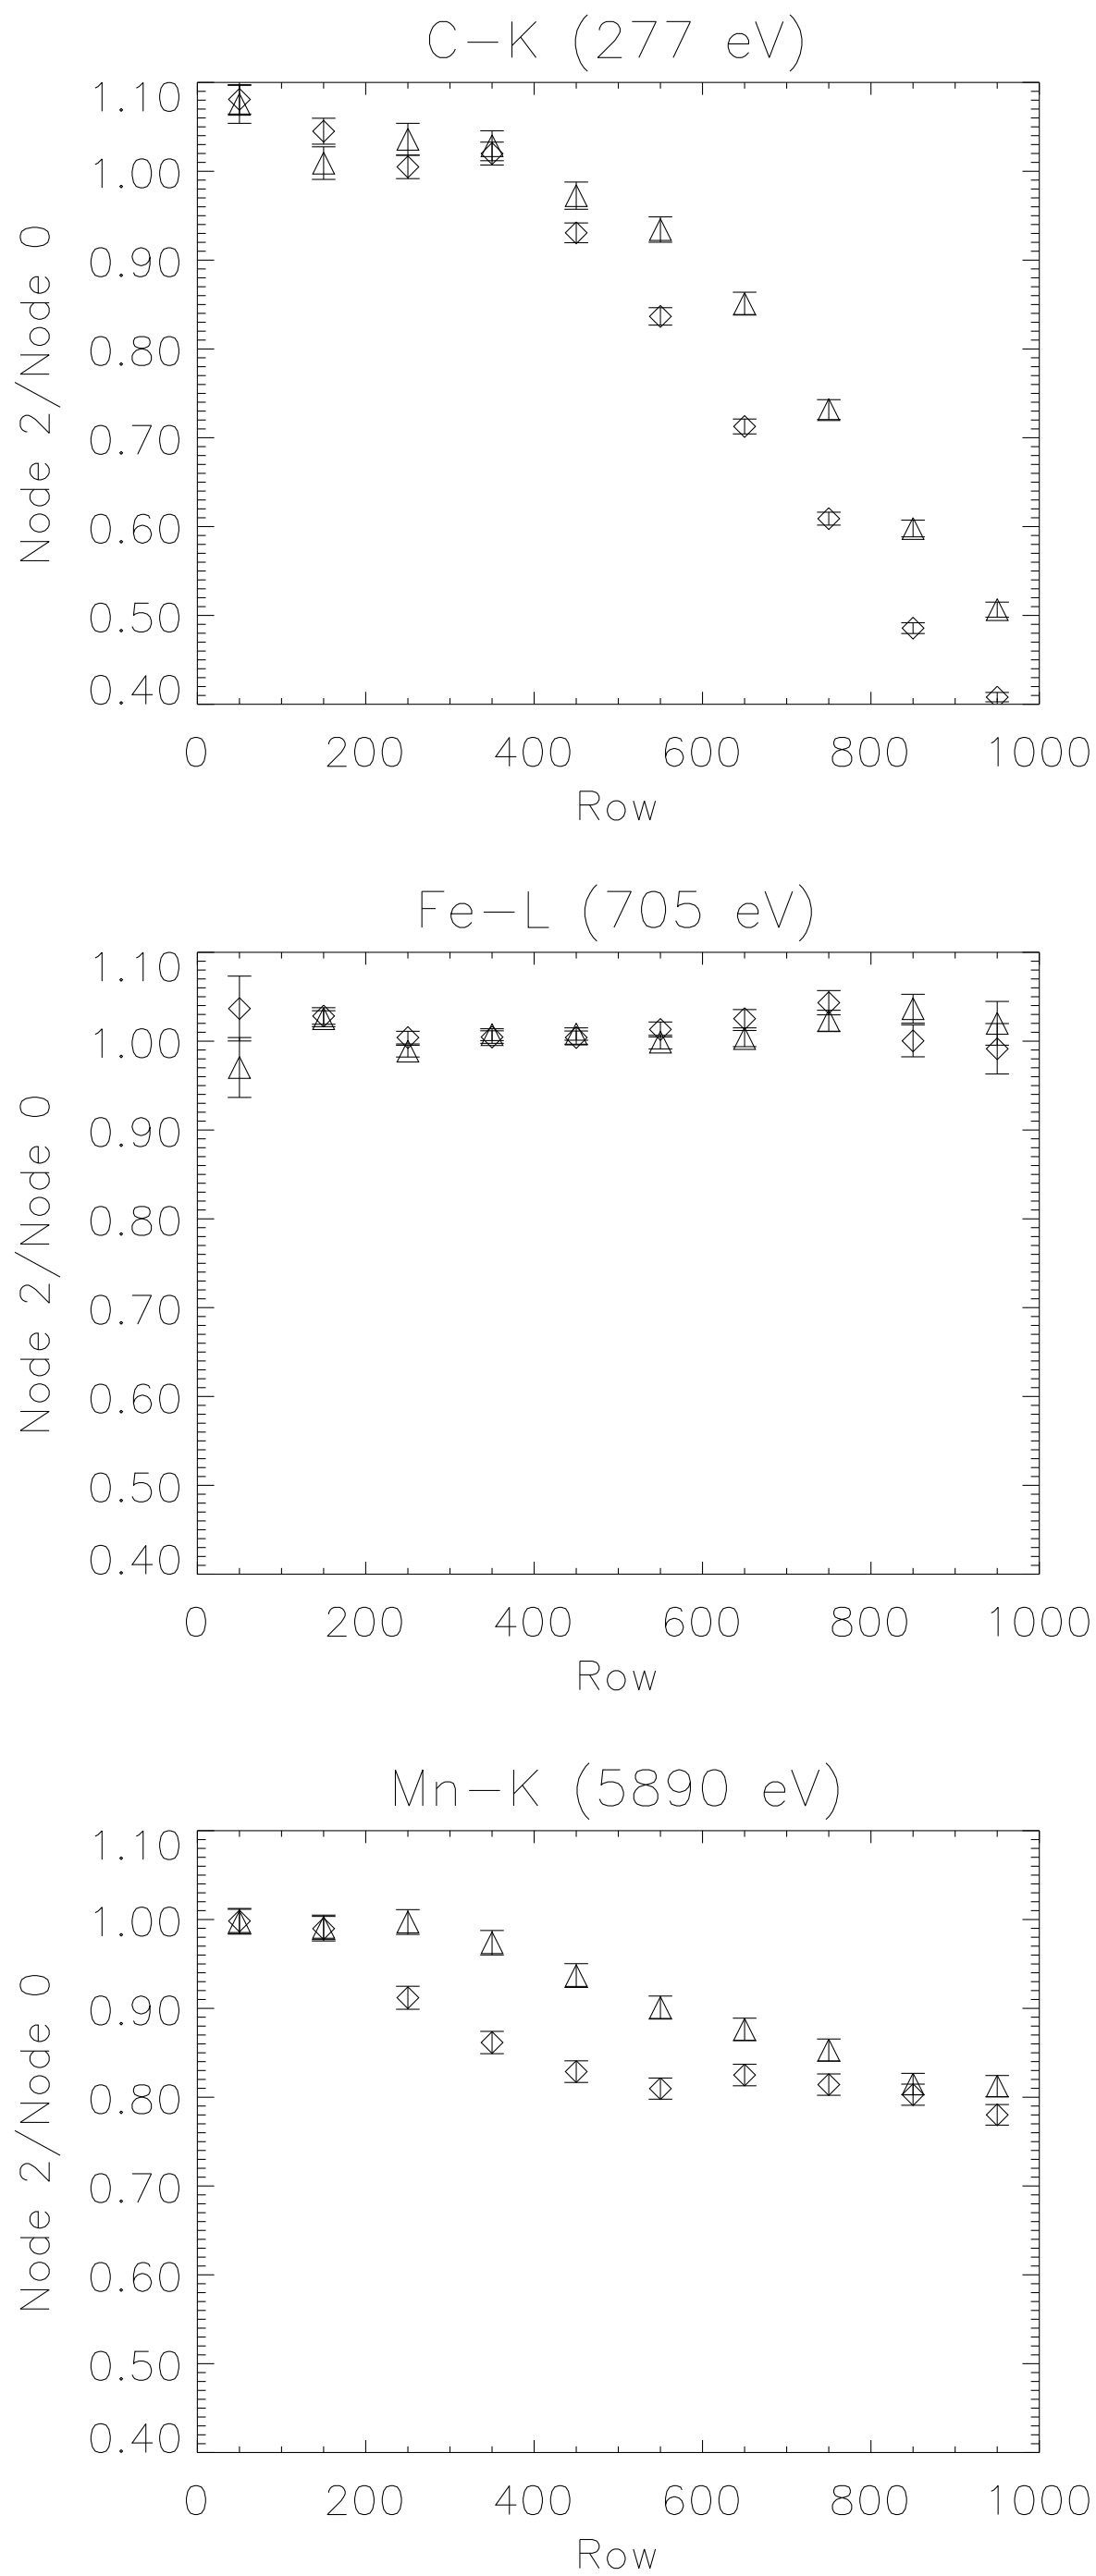
Figure 2 shows the dependence of QE on row number for each of the spectral lines. The C-K line shows a strong dependence of QE on row number. Below row 400, little QE degradation is seen. By rows 900-1000, the relative QE of node 2 to node 0 has decreased to 40% (-110 C) and 50% (-120 C). The O-K, Fe-L, and Al-K lines show little row dependence of QE. The Mn-Kα line shows a drop of 20% in relative QE to $\sim$ 80% for both temperatures. The leveling off of row-dependent QE at Mn-Kα may indicate a saturation of grade morphing, as grades susceptible to morphing into bad grades are exhausted. These are primarily grade 6 events which morph into grade 7.

Figure 2: Relative QE as a function of row for each spectral line at -110 C ($\diamond$) and -120 C ($\triangle$).

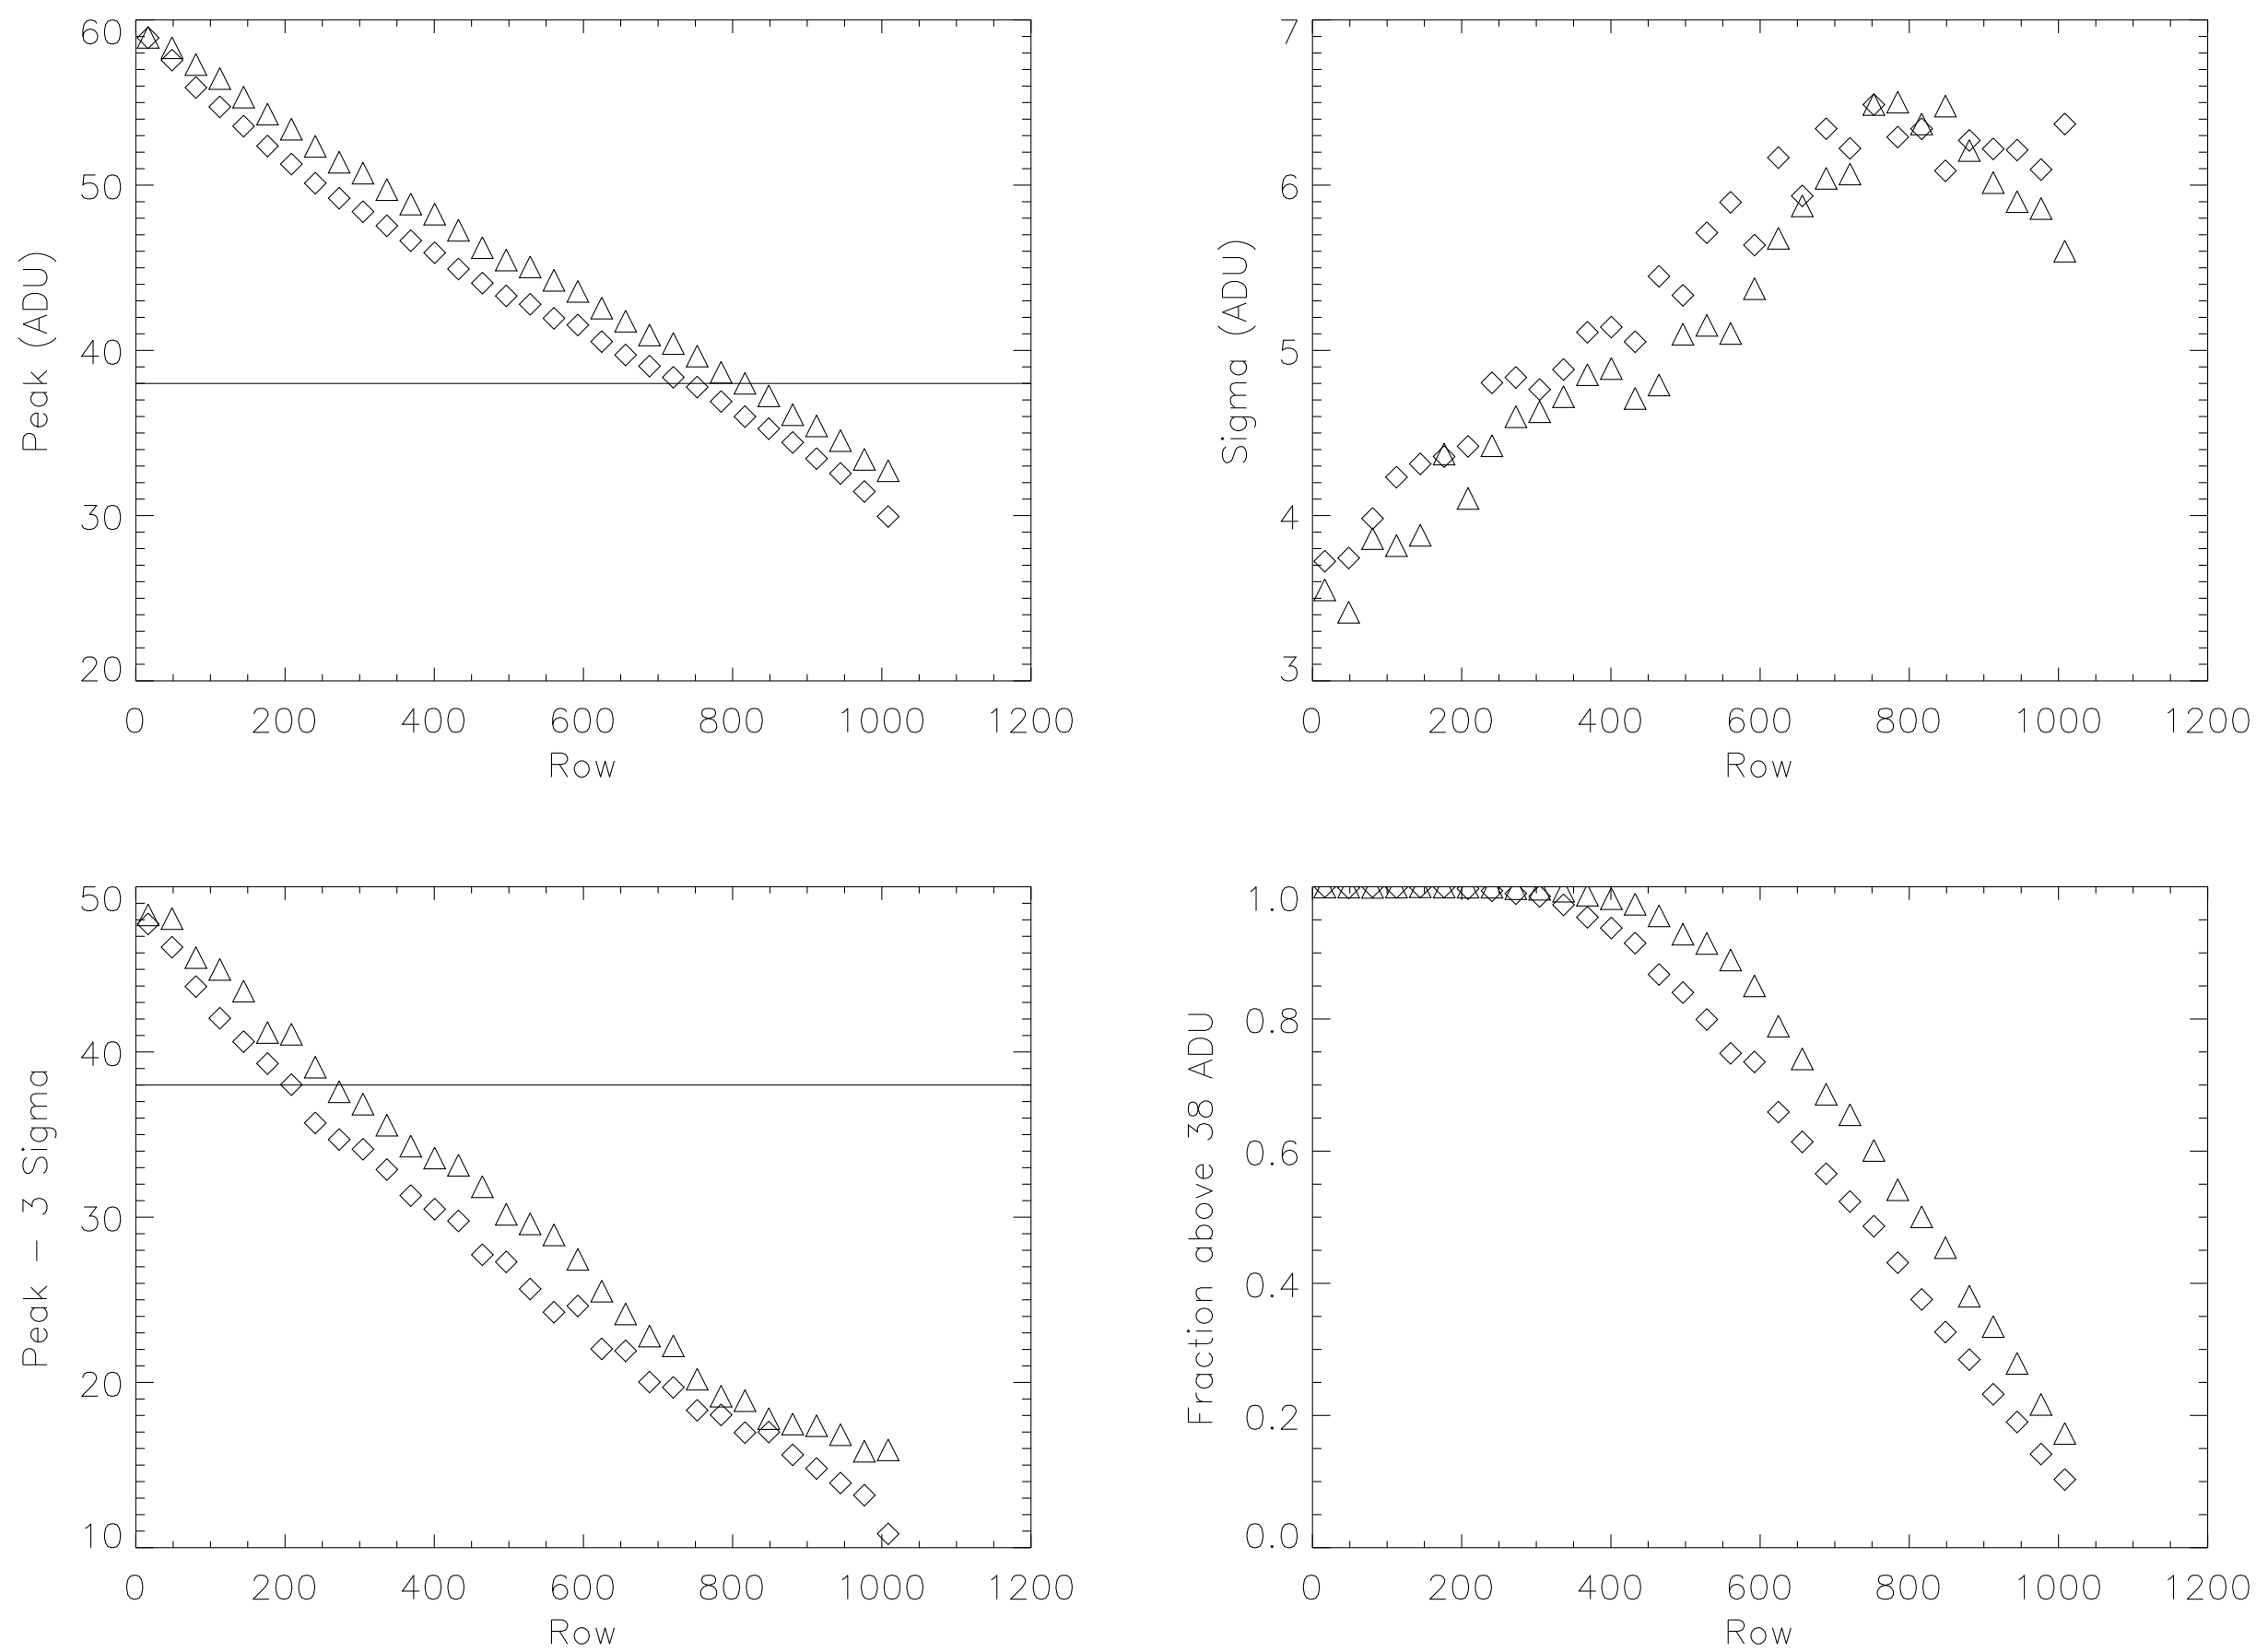
Figure 3 demonstrates a second way of examining the decrease of QE at low energies in the damaged node as a function of row number. For this example, the data is grouped into 32 bins of 32 rows each and a Gaussian is fit to the summed pulseheight from G02346 events. The event threshold has been lowered to 13 ADU to study the QE behavior around 38 ADU. Results of Gaussian fits from analysis by Bev LaMarr. The top panels show the peak location (μ) and sigma (σ) from a Gaussian fit to the C-K line as a function of row number at -110 and -120 C. The Gaussian width decreases at the highest row numbers as counts are lost below the 13 ADU threshold. The line centroid drops below the flight event threshold around row 750 (-110 C) and 850 (-120 C).

One can define a critical row number y_{crit} where the decrease in QE from radiation damage becomes significant, i.e. ΔQE $>$ 1%. A Gaussian integrated from μ - 3σ to ∞ includes 99% of the flux. The bottom left panel shows the Gaussian peak minus three sigma ($\mu - 3\sigma$) as a function of row. The event threshold of the flight instrument (38 ADU) is shown as a horizontal line. y_{crit} is $\sim$ 200 at -110 C and $\sim$ 250 at -120 C. The bottom right panel shows the fraction of the integrated counts under the Gaussian that are above 38 ADU. At the top of the CCD, the fraction above 38 ADU is less than 20%. This result differs from Figure 2 because Figure 2 calculates the QE loss from the entire spectrum including piled up counts and therefore underestimates the true loss of QE from CTI. At -110 C, ΔQE $\approx$ 10% at row 450 and 50% at row 750. At -120 C, ΔQE $\approx$ 10% at row 575 and 50% at row 800.

Figure 3: Results of Gaussian fits to the C-K line (277 eV) in the damaged portion of the CCD at -110 C (⋄) and -120 C (△). See the text for explanation. The horizontal line indicates the flight instrument event threshold of 38 ADU.

While these results suggest that lowering the on-board event threshold would improve the low energy quantum efficiency at high row numbers, lowering the event threshold would also admit many more non-X-ray events quickly saturating telemetry. The gain in quantum efficiency would be offset by a loss of observing efficiency as many CCD frames would be dropped by the on-board software and lost.

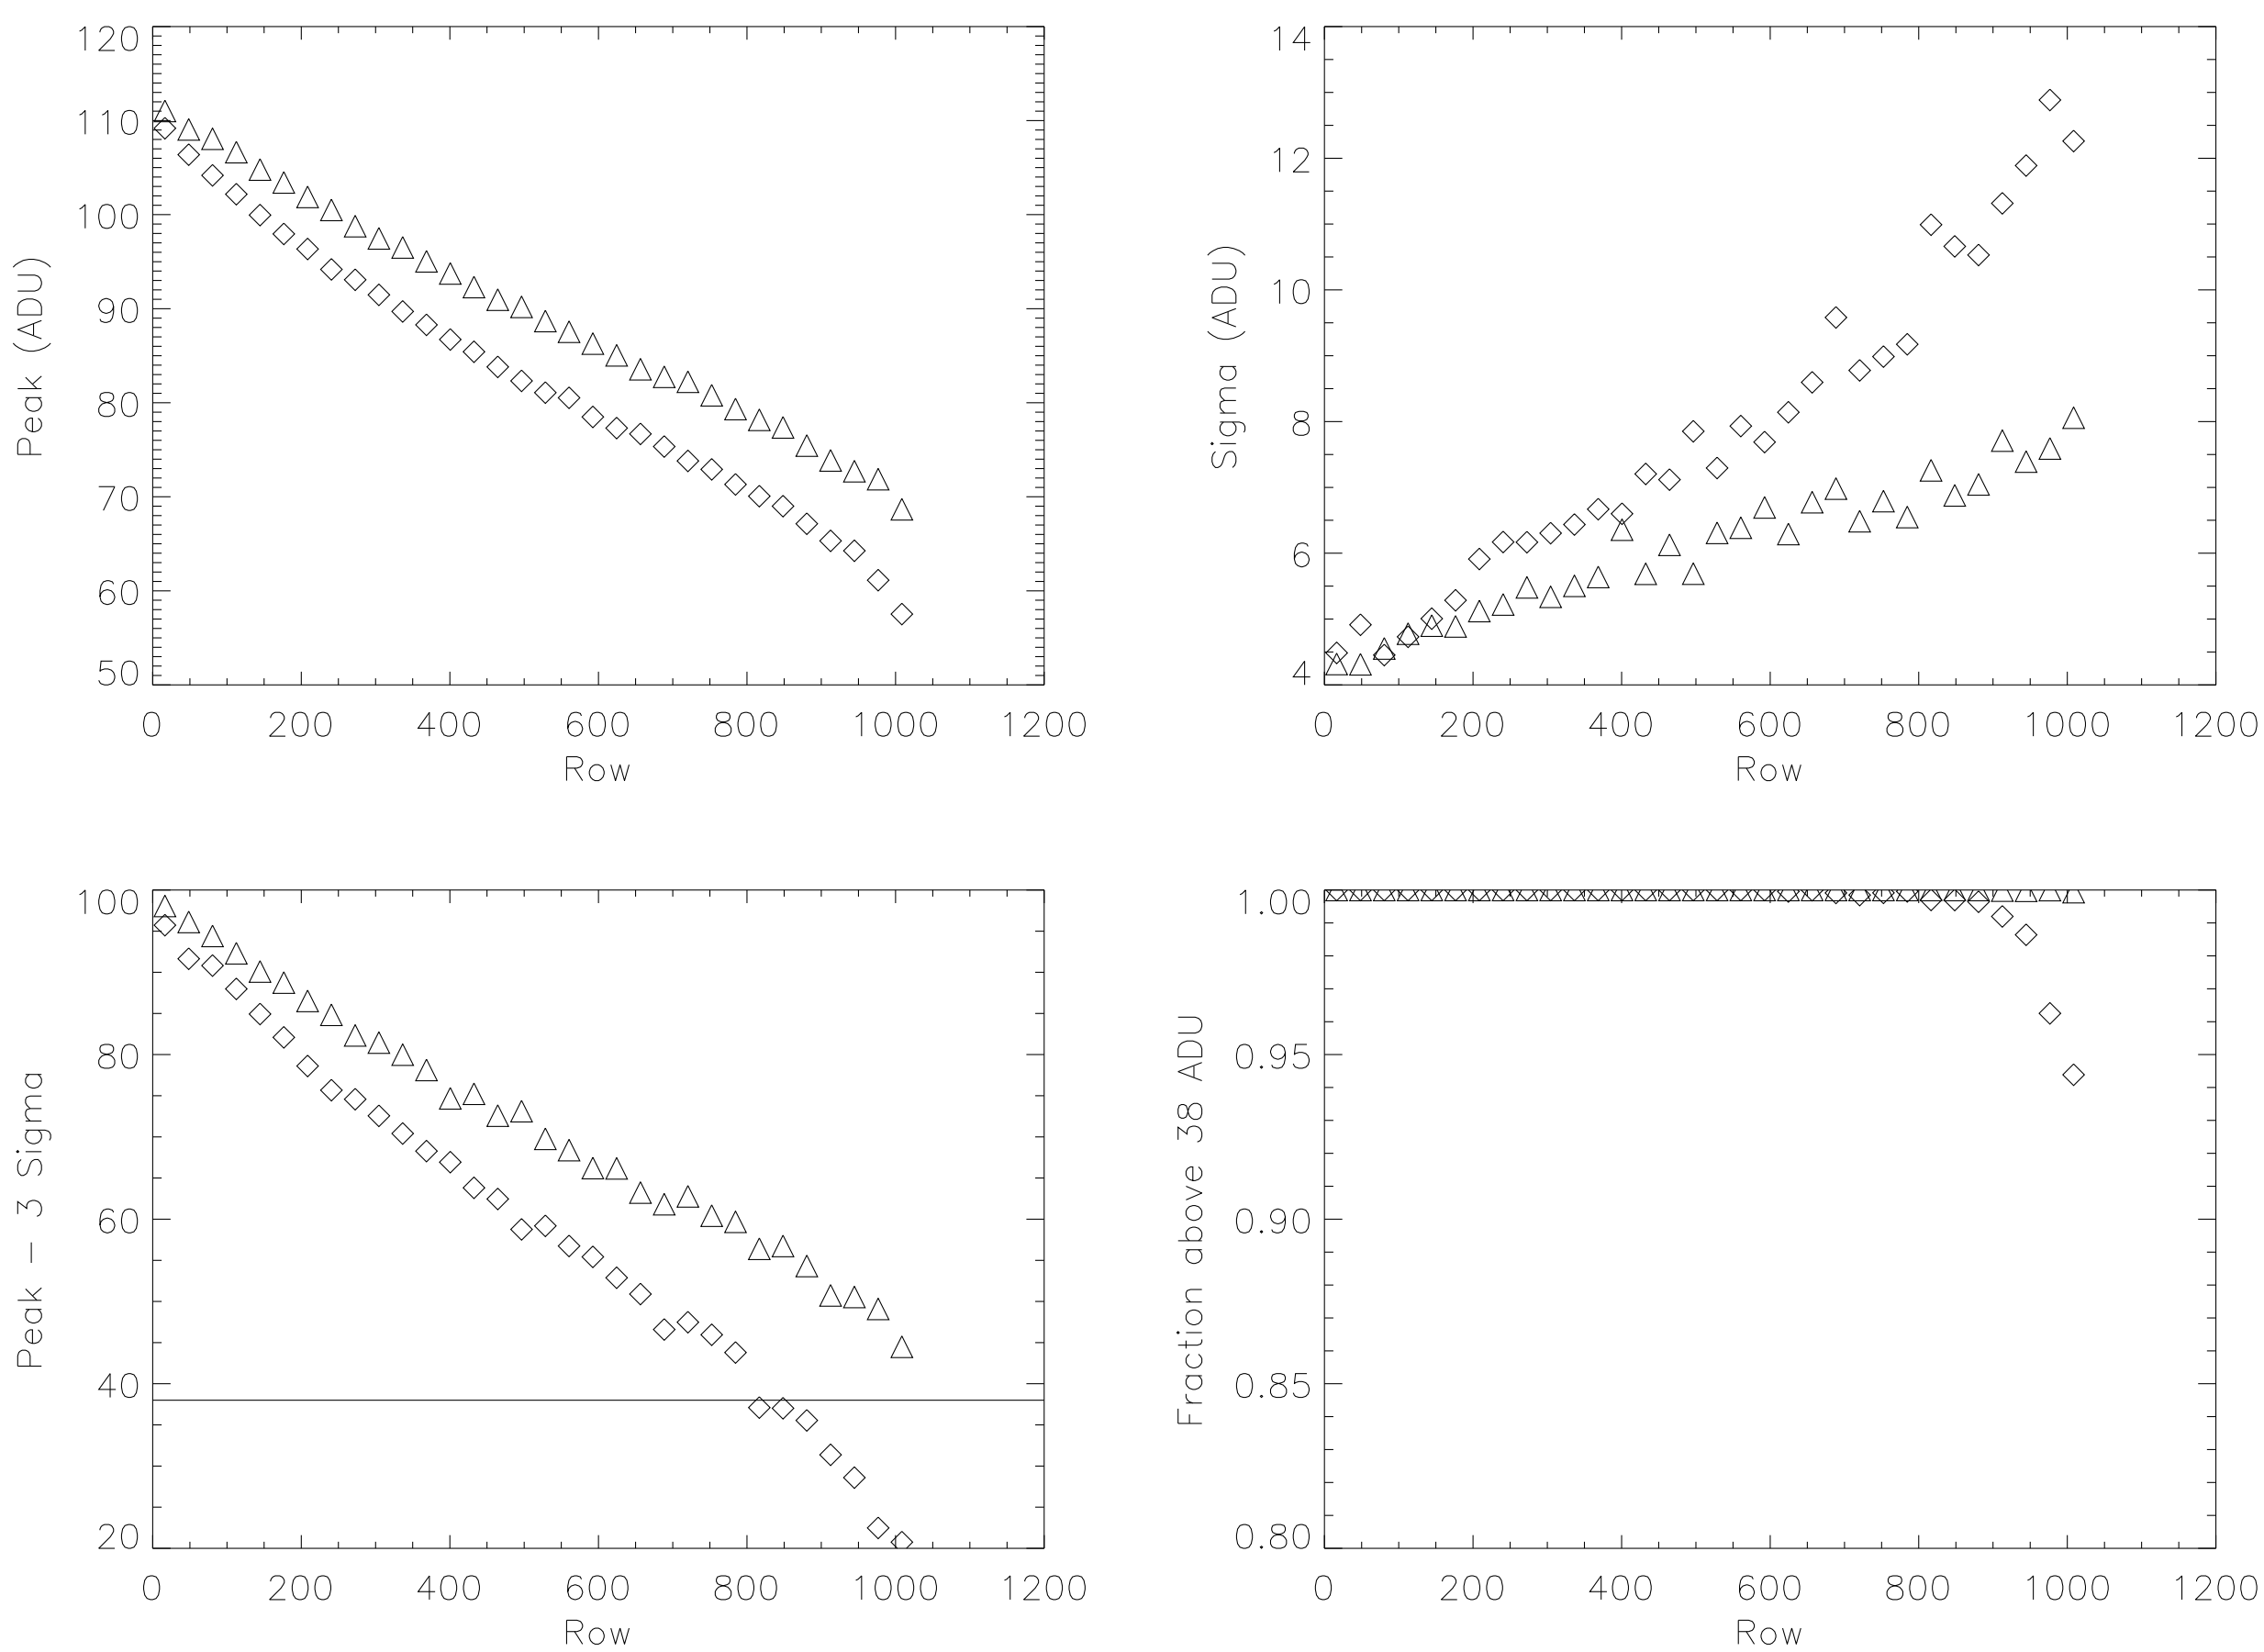
Figure 4 shows the same results for the O-K line. At this energy, very little QE is being lost at the top of the CCD. At -110 C, ΔQE $\approx$ 6% at row 1000. At -120 C, ΔQE $<$ 1% at row 1000.

Figure 4: Same as figure 3 for the O-K line (525 eV).
